## Case 248 : Narrative

Case Vehicle (A): 1998 Ford	Veh. (B): 1999 Jeep
Type: Escort SE Sport, 4-door sedan	Type: Grand Cherokee, 4 x 4, 4-door SUV
Driver: 33-year-old female	Driver: 50-year-old male
CDC: 01-FDEW-2	CDC: 12-FYEW-2

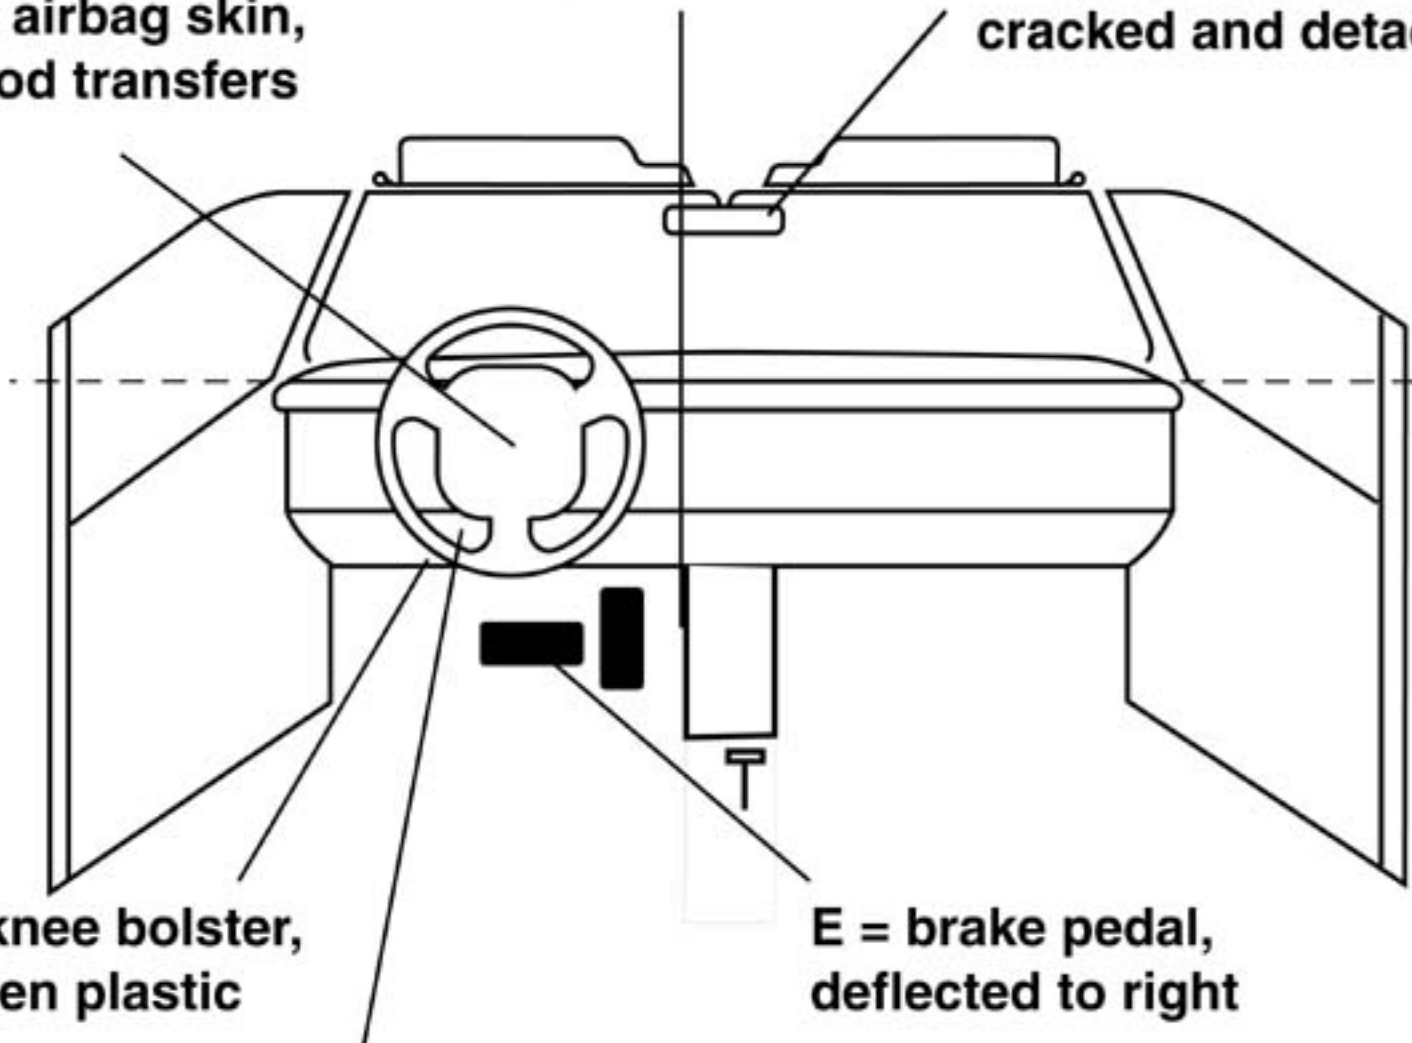
## INTRUSION IT-1

**C = vertical console,  
cracked plastic**

**F = rear view mirror,  
cracked and detached**

**A = knee bolster,  
broken plastic**

**E = brake pedal,  
deflected to right**

**B = steering column,  
cracked plastic and scuff marks**
